**INKAMPANI YAMAPAYIPI**  
The Pipe Company

**Thermogram 11 August 2014**

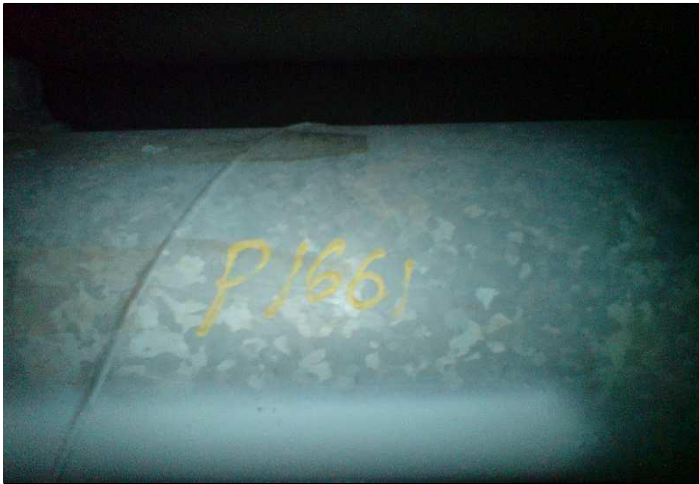
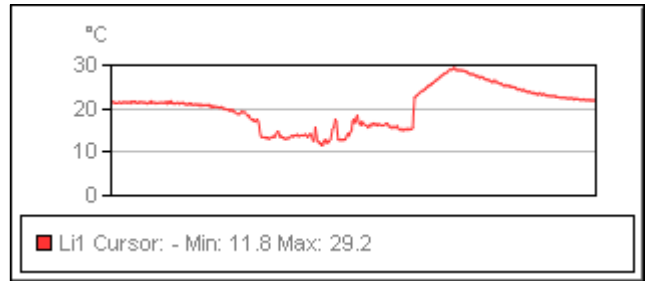
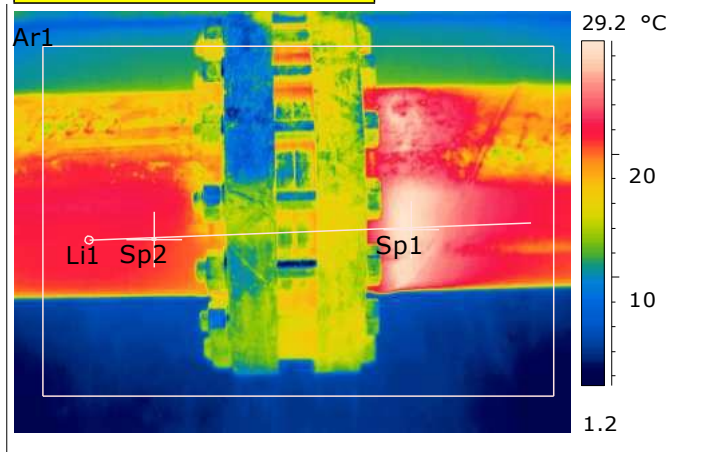
Location	Mine N
Equipment	Pipe Line
Equip Number	1661
Compartment	From flange

Sp1 Temperature	28.6 °C
Sp2 Temperature	21.1 °C
Ar1 Max. Temperature	29.4 °C
Li1 Max. Temperature	29.2 °C
Object Distance	1.0 m
Emissivity	0.87
Longitude	E 30° 38.288'
Latitude	S 25° 47.456'

*Image suggests a tear in the lining (At night high emissivity). It is recommended to open and inspect.*

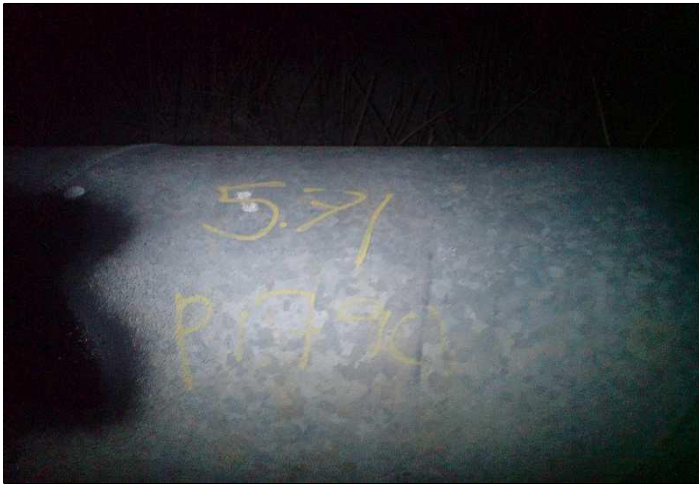
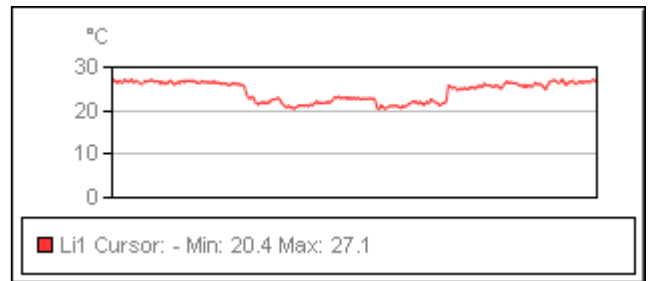
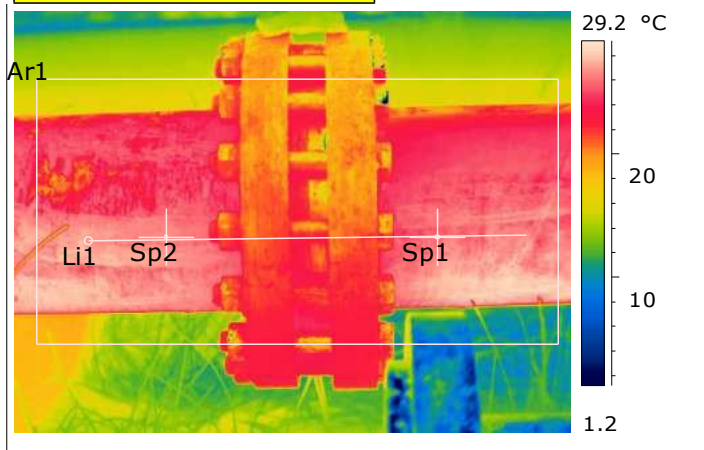
Location	Mine N
Equipment	Pipe Line
Equip Number	1790
Compartment	From Flange

Sp1 Temperature	26.0 °C
Sp2 Temperature	26.6 °C
Ar1 Max. Temperature	28.8 °C
Li1 Max. Temperature	27.1 °C
Object Distance	1.0 m
Emissivity	0.87
Longitude	E 30° 38.615'
Latitude	S 25° 47.684'

*No anomaly. No action required*

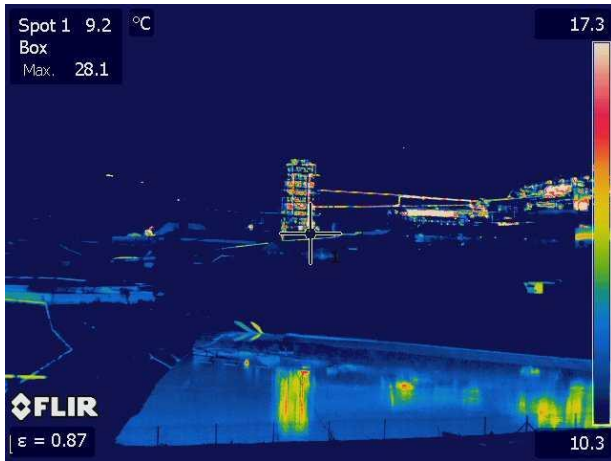
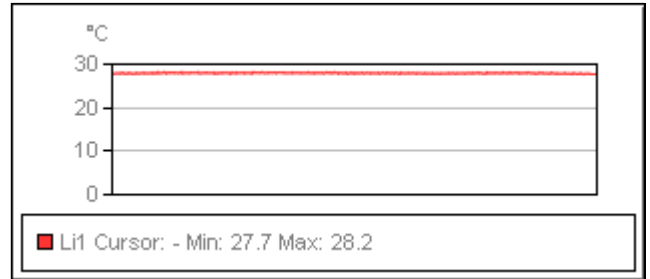
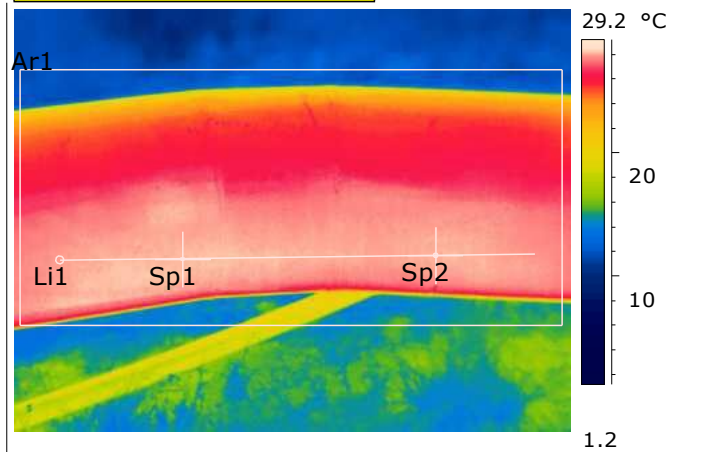
<i>Location</i>	<i>Mine N</i>
<i>Equipment</i>	<i>Pipe line</i>
<i>Equip Number</i>	<i>Dam Pipe Bend</i>
<i>Compartment</i>	<i>Bend</i>

Sp1 Temperature	28.0 °C
Sp2 Temperature	27.9 °C
Ar1 Max. Temperature	28.2 °C
Li1 Max. Temperature	28.2 °C
Object Distance	1.0 m
Emissivity	0.87
Longitude	E 30° 39.27'
Latitude	S 25° 49.613'

*Image suggest no damage on lining – no action required*

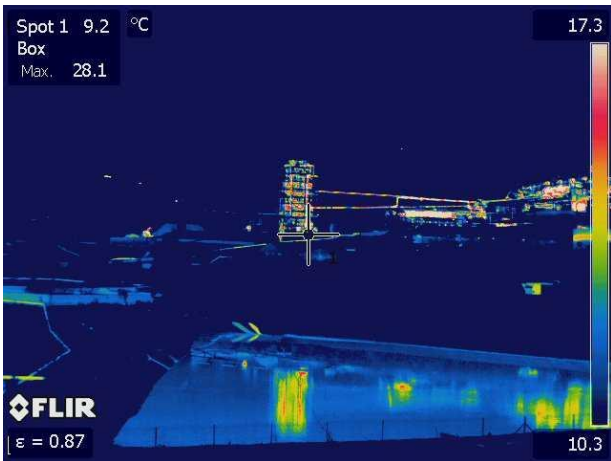
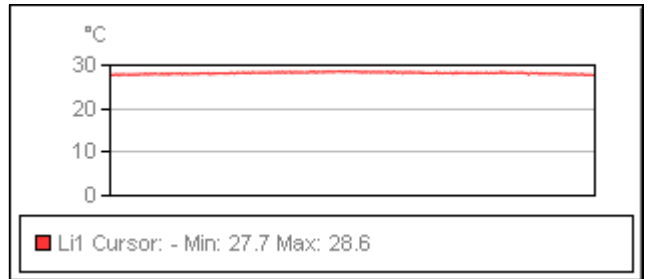
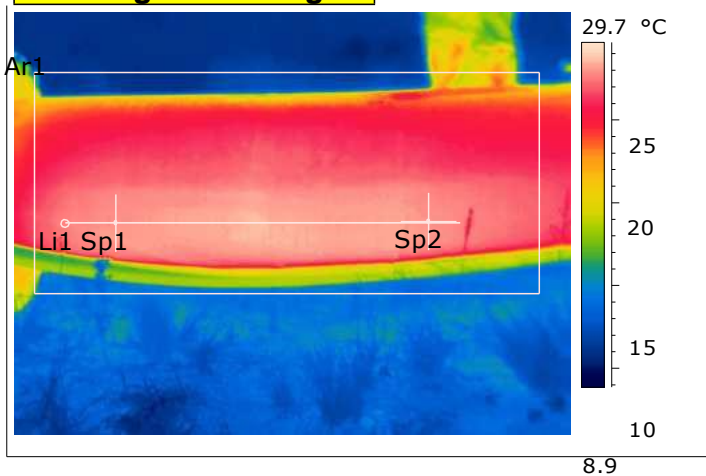
<i>Location</i>	<i>Mine N</i>
<i>Equipment</i>	<i>Pipe Line</i>
<i>Equip Number</i>	<i>Dam Pipe Line</i>
<i>Compartment</i>	<i>Bend</i>

Sp1 Temperature	28.0 °C
Sp2 Temperature	28.1 °C
Ar1 Max. Temperature	28.6 °C
Li1 Max. Temperature	28.6 °C
Object Distance	1.0 m
Emissivity	0.87
Longitude	E 30° 39.30'
Latitude	S 25° 49.612'

*Image suggest no damage on lining – no action required*

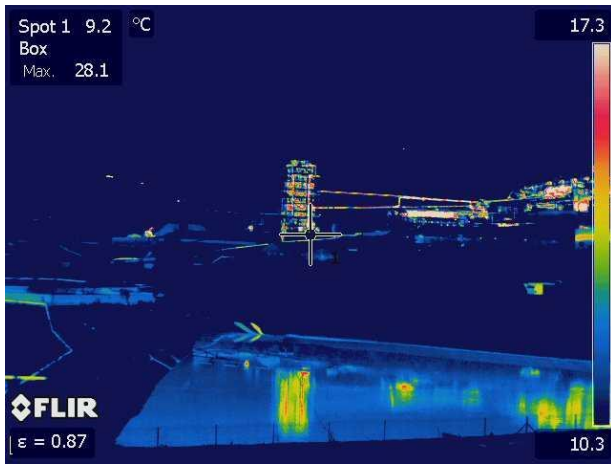
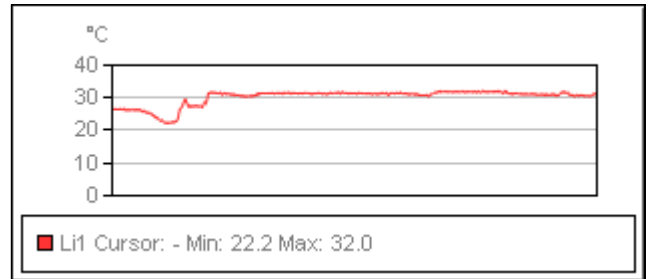
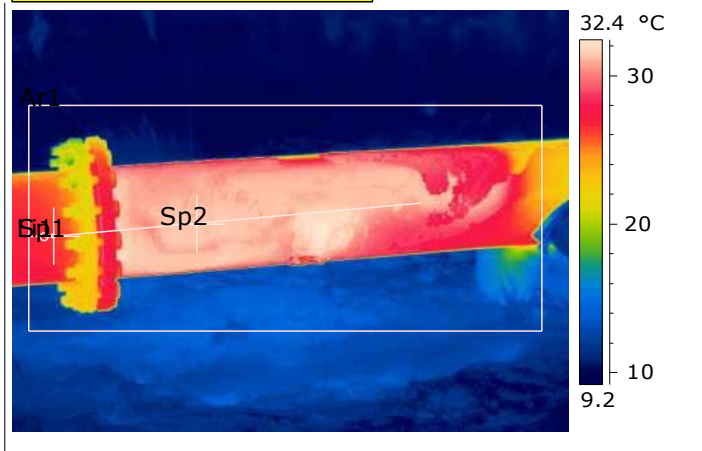
Location	Mine N
Equipment	Pipe Line
Equip Number	Dam Pipe
Compartment	From flange

Sp1 Temperature	26.5 °C
Sp2 Temperature	31.5 °C
Ar1 Max. Temperature	32.5 °C
Li1 Max. Temperature	32.0 °C
Object Distance	1.0 m
Emissivity	0.87
Longitude	E 30° 39.47'
Latitude	S 25° 49.690'

*Image suggest damage on lining – action to be taken*

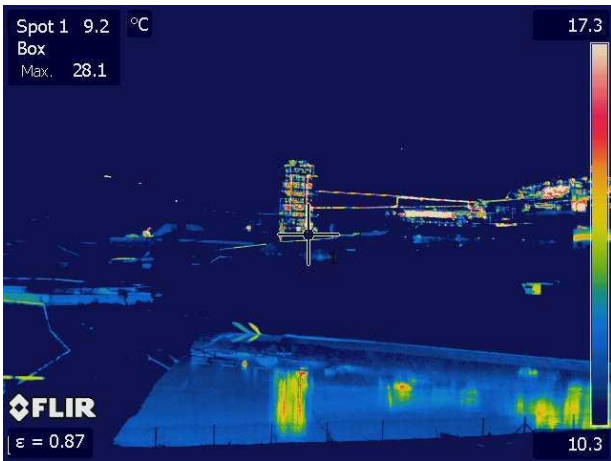
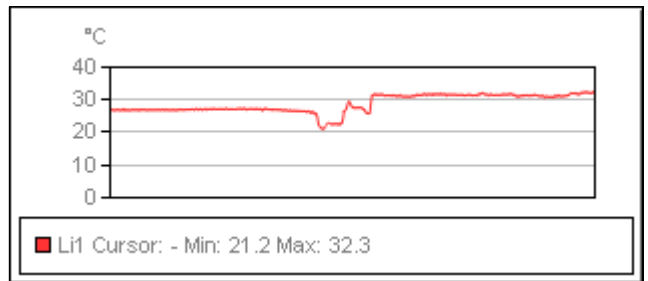
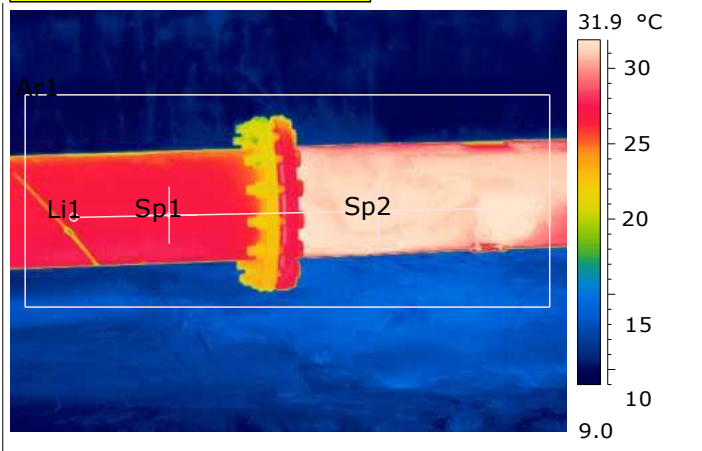
<i>Location</i>	<i>Mine N</i>
<i>Equipment</i>	<i>Pipe Line</i>
<i>Equip Number</i>	<i>Dam Pipe</i>
<i>Compartment</i>	<i>From Flange</i>

Sp1 Temperature	27.1 °C
Sp2 Temperature	31.5 °C
Ar1 Max. Temperature	32.6 °C
Li1 Max. Temperature	32.3 °C
Object Distance	1.0 m
Emissivity	0.87
Longitude	E 30° 39.47'
Latitude	S 25° 49.690'

*Image suggest damage on lining – action to be taken*

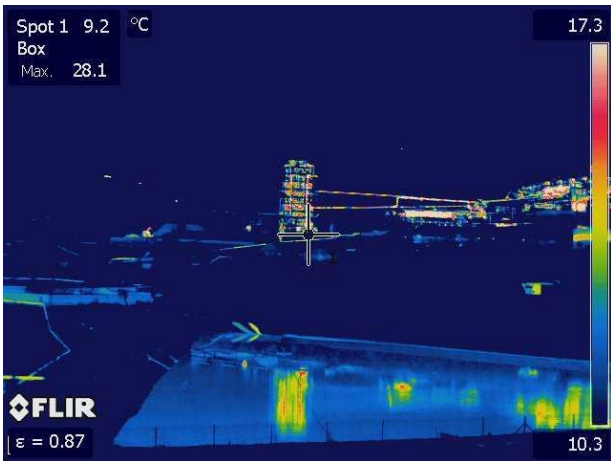
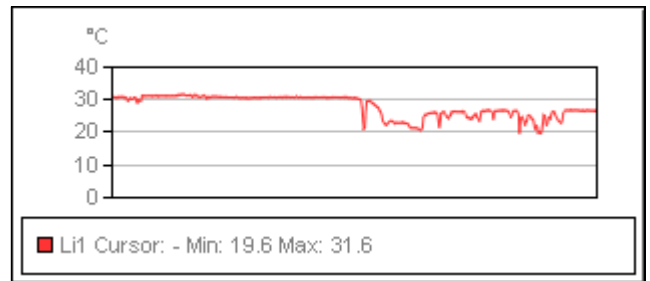
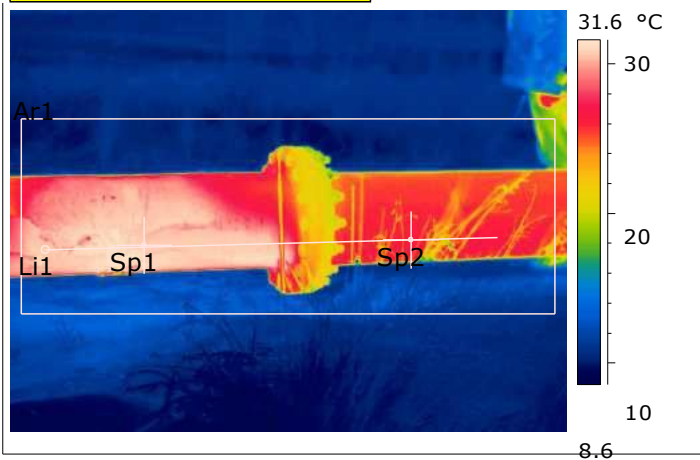
<i>Location</i>	<i>Mine N</i>
<i>Equipment</i>	<i>Pipe Line</i>
<i>Equip Number</i>	<i>Dam Pipe</i>
<i>Compartment</i>	<i>From Flange</i>

Sp1 Temperature	30.9 °C
Sp2 Temperature	26.7 °C
Ar1 Max. Temperature	31.8 °C
Li1 Max. Temperature	31.6 °C
Object Distance	1.0 m
Emissivity	0.87
Latitude	S 25° 49.689'
Longitude	E 30° 39.41'

*Image suggest damage on lining – action to be taken*
